# Recent Renovation and Modernization Technologies for Existing Hydro Turbine

B. Prabhakar<sup>1)</sup> and G. K. Pathariya<sup>2)</sup>

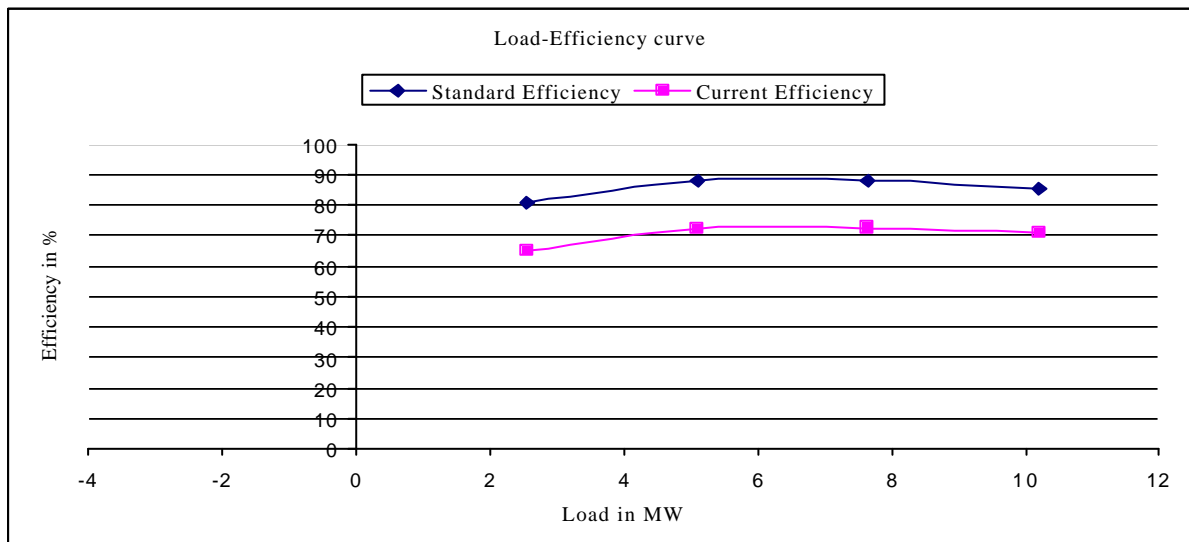
Chart 01 Curve between load & efficiency.

Efficiency loss= Standard efficiency – current efficiency= 85.50 – 70.11= 15.38%

The availability of the plant for one year is 55.47% .the curve shown in figure no. 01 shows that graph between load & efficiency. Due to old age the efficiency of the plant was decreases approximate 15.38% and the generation losses per KWh is Rs 34680 for one unit. If we will not take any step towards applied recent technologies and renovation and modernization then definitely it will be tripe the whole plant as well as generation losses.

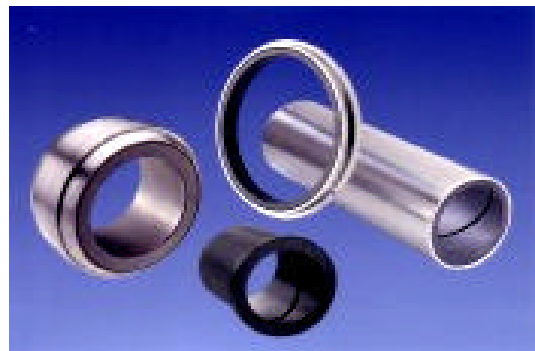
Figure - 04 Graphalloy bushing

A graphite-metal alloy is a dry, self-lubricating alloy with a low coefficient of friction. Graphalloy bushings provide lifetime cost and operating advantages over other materials as shown in fig.04.

- Graphalloy bushings work where others won't. You can replace ball bearings, metal and plastic bushings, and ordinary hard carbon bushings.
- It bushings reduce maintenance and downtime.
- It is a self lubricating material and operates as a bearing without additional lubrication. These long-wearing bushings never need lubrication.
- Graphalloy bushings are available in over 100 grades with specific properties that meet a wide range of engineering solutions and specifications. The most used graphalloy materials are Babbitt, copper, bronze, nickel, and silver.
- Graphalloy provides design freedom, improves turbine efficiency and improves reliability.

Self Lubricating, No Grease or Oil, High Temperature Operates from  $-450^{\circ}$  to  $1500^{\circ}$  F (  $-240^{\circ}$  to  $800^{\circ}$  C), Low Coefficient of Friction, Chemical Resistant , Tolerant to Dust, No Oil Contamination & Reduced Downtime.

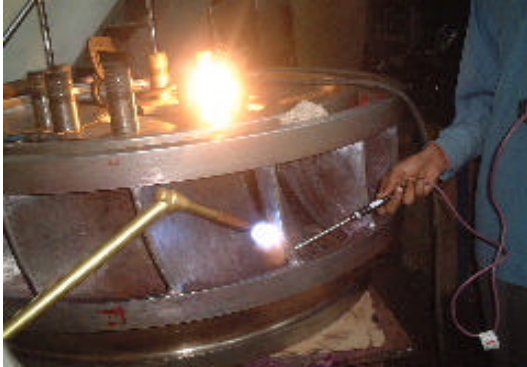
Figure 5. Runner preheating

Welding is the most common and, to date, the most successful method of repairing cavitations damage on hydraulic turbines. The various steps for repair by welding are as follows:

Pre dimension check, preheating of cavitation area shown in figure 5 and 6, TIG welding, Grinding of welding area, weld inspection and dye penetration test and Final dimensional checks.

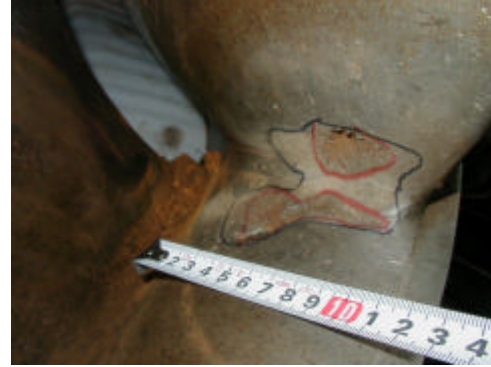
Figure 6 Runner cavitation

Examination of the runner of a hydraulic turbine or the impeller of a pump often discloses pitted areas in various stages of development. Pitted areas may also be found on turbine or pump water passage surfaces where water velocities are high. This damage is generally termed cavitations erosion or impingement erosion. Because of various physical conditions present in the water flow system, a cycle of cavitations is induced as follows:

Extreme low-pressure areas are produced by flow irregularities. Pockets or "cavities" of vapor form. Pressure and flow conditions change abruptly. The pockets or "cavities" collapse causing high shock pressures. Where the collapse occurs adjacent to a metal surface, the resultant impact tears out bits of the metal.

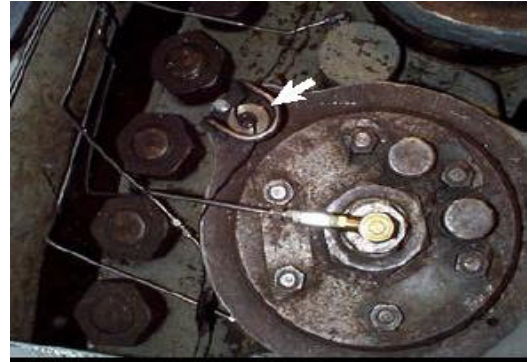
Fig.7 shear pin detector in guide vane arm

Shear pin detector shown in figure 7 for fast identification of a broken shear pin. A shear pin is a mechanical fuse that breaks when too much effort is applied on a wicket gate. It protects the wicket gates and related mechanism against major damage when its blocked by debris during closure. When it happens, it is important to quickly identify which shear pin is broken. The breaking detector to the rescue:- the breaking detector for shear pin is a unique piece with LED light on the top that fits in to the shear pin. Each detector is connected and to an alarm. When a shear pin breaks, the light of its breaking detector turn on and the alarm is triggered. On average, a turbine has about 20-wicket gates each protected by a shear pin and to be equipped with a breaking detector.
